## **Scalable and Modular robotic tools for pipeline inspection and repair**

### **DELIVERABLE 8.2**

## **REPORT ON TUBERS PERFORMANCE ASSESSMENT**

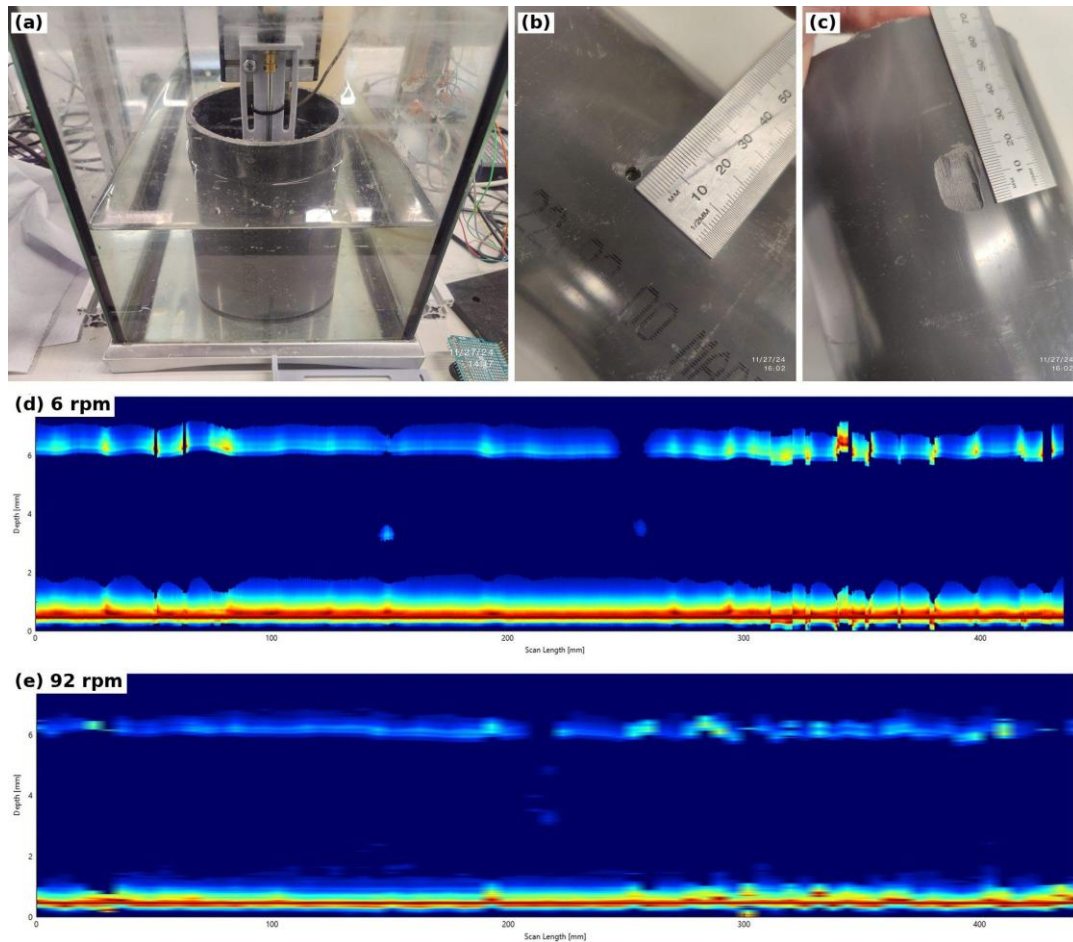
Laboratory tests covered steel calibration blocks, a 12 mm stainless-steel plate with artificial pitting and PVC pipe sections with drilled holes and wall-loss patches. Figure 8 shows circumferential B-scans of an immersed grey PVC pipe: the inner and outer wall echoes clearly bound the ≈6 mm wall, and the artificial defects appear as interruptions of the back-wall echo with intermediate indications. The defects remain detectable at 92 rpm as well as at 6 rpm, i.e. at about 15 times the rotation speed, which is what makes fast in-pipe screening feasible.

Figure 8: Laboratory B-scans of a grey PVC pipe with artificial defects: (a) immersion set-up, (b) drilled hole, (c) wall-loss patch, (d) B-scan at 6 rpm, (e) B-scan at 92 rpm

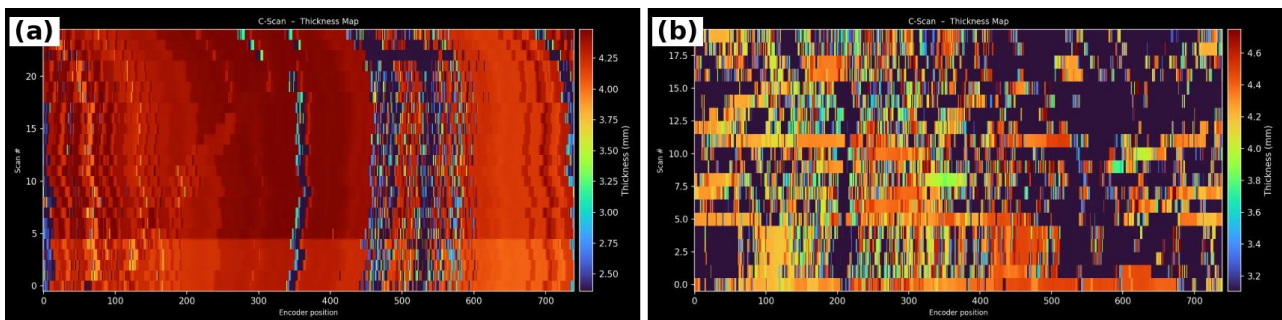
At the final demonstration the complete chain (i.e. soft-robot locomotion in 5 mm axial steps, 360° acquisition, transmission, live C-scan and export) ran in-pipe for the first time (§3.2.3). The compliant robot body did not hold the probe coaxial with the pipe, so the thickness readings in that configuration were not consistent. THL reproduced the condition in the laboratory with a soft jig (Figure 10): with the best alignment the C-scan returns a consistent wall thickness of 4.2–4.4 mm over most of the circumference, apart from the expected dead zones behind the pneumatic lines, whereas a misalignment of only 2–5° scatters the readings. This confirms that the UT electronics and firmware perform as designed and that probe alignment is the single condition for valid in-pipe data. Three refinements follow:

Figure 10: Laboratory C-scan thickness maps with the UT module held in a soft jig: (a) best achievable alignment, (b) misalignment of approximately 2–5°

- **Alignment:** a rigid centraliser or spring-loaded guides around the module to hold the probe coaxial with the pipe.
- **Dead zones:** double-pass scanning with a slight rotation of the robot, merged in post-processing.
- **Motor coasting:** position-based mirror control, replacing the current manual row-shift correction in the GUI.

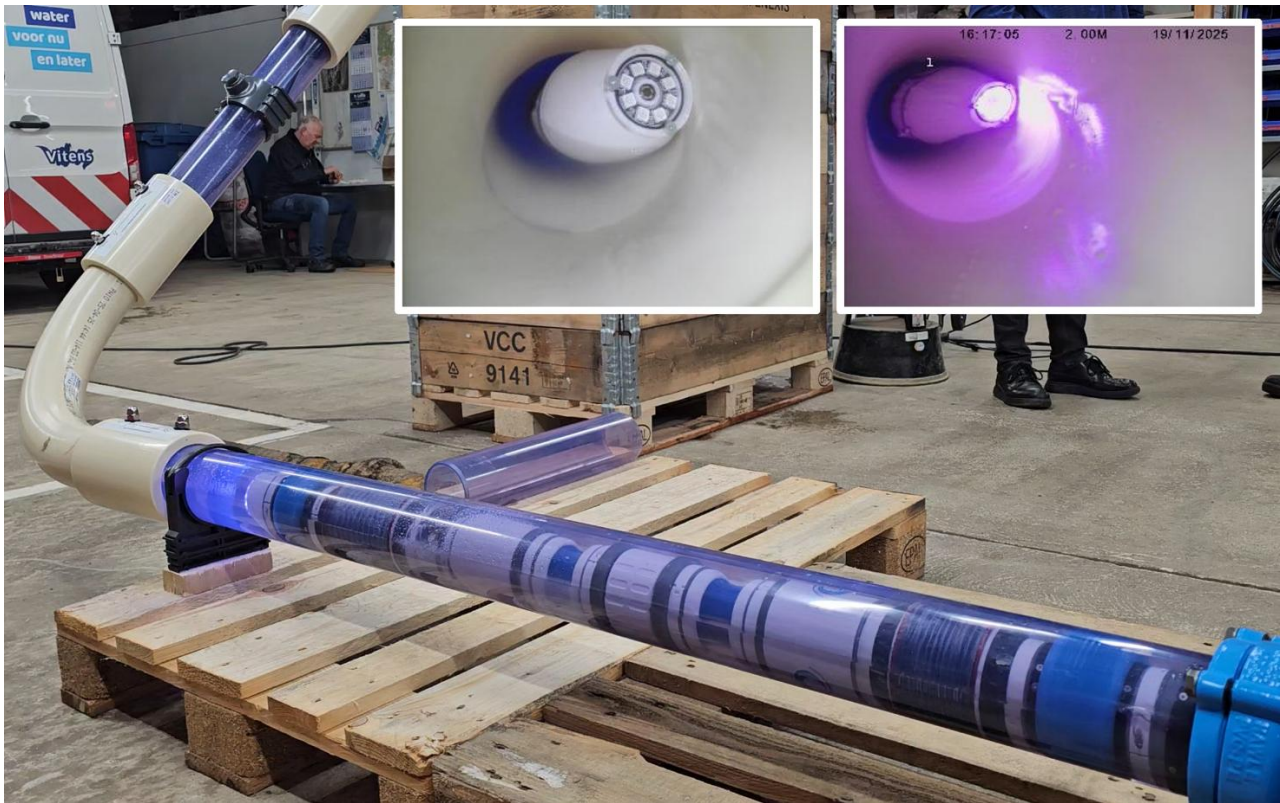
During the trials both versions of the robot were assessed for their ability to traverse the network, navigate complex features, maintain watertightness, climb inclined and vertical pipes, capture defect

*Figure 13: VITENS Preliminary Trials - Full Robot Wet Tests.*

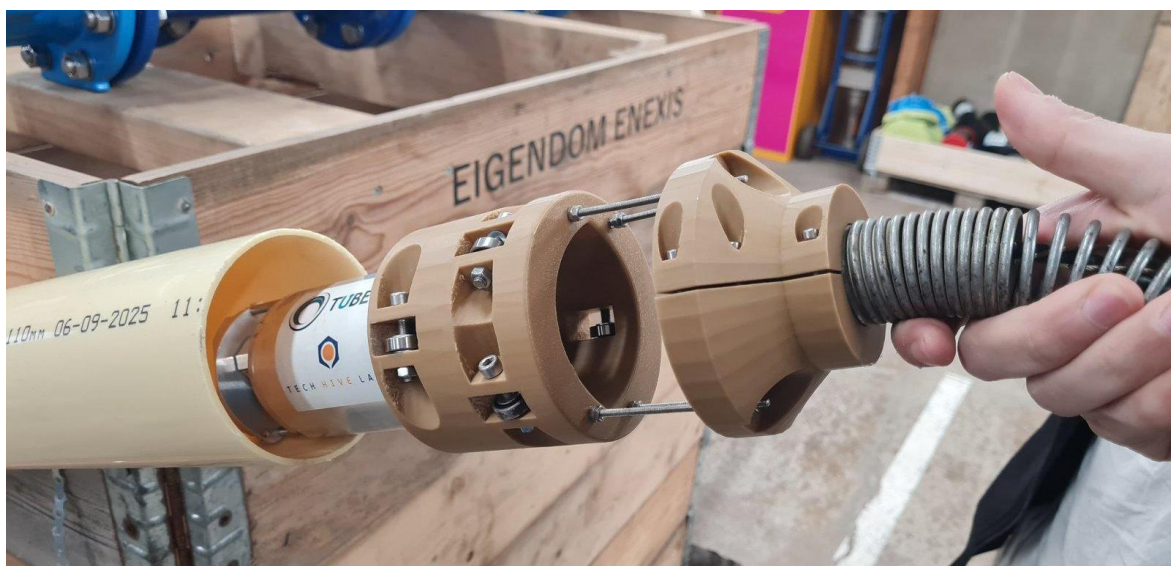
*Figure 16: VITENS Preliminary Trials - UT module mounted on the VITENS push-rod system with a custom adapter*

A fault on the UT electronics board occurred before the measurement runs started, so no ultrasonic data were recorded at VITENS. The UT electronics stack was subsequently troubleshoot component by component (February–March 2026) and brought back to an operational state, enabling the synchronised in-pipe scans demonstrated at Bendabl (§3.2).

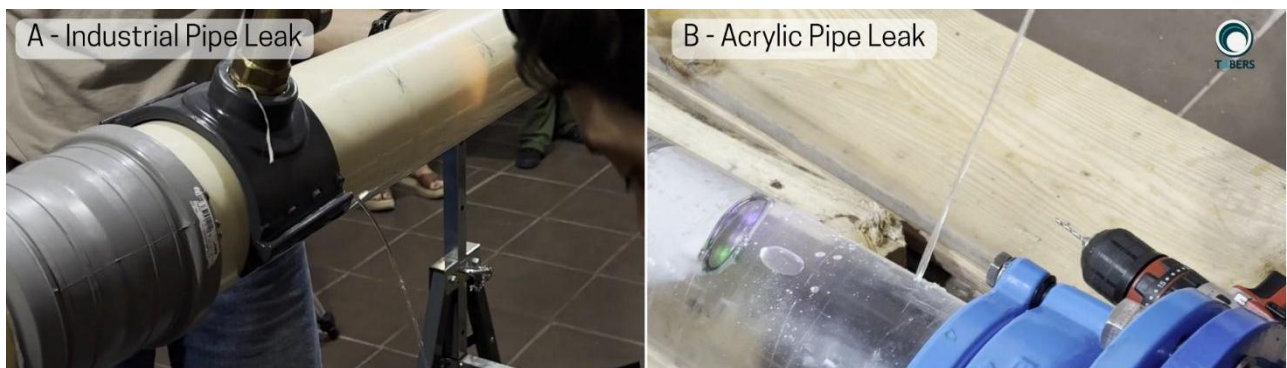
Two artificial leaks were introduced in front of the attendees (Figure 22): a hole in the elevated industrial PE/PVC pipe, used for the complete end-to-end mission, and a hole in a transparent acrylic section, used to show the repair mechanism at work from outside the pipe.

Figure 22: Two defects were demonstrated in the workshop. PE/PVC Pipe (Left) for demonstrating the end-to-end process and Transparent Acrylic Pipe (Right) for demonstration purposes.

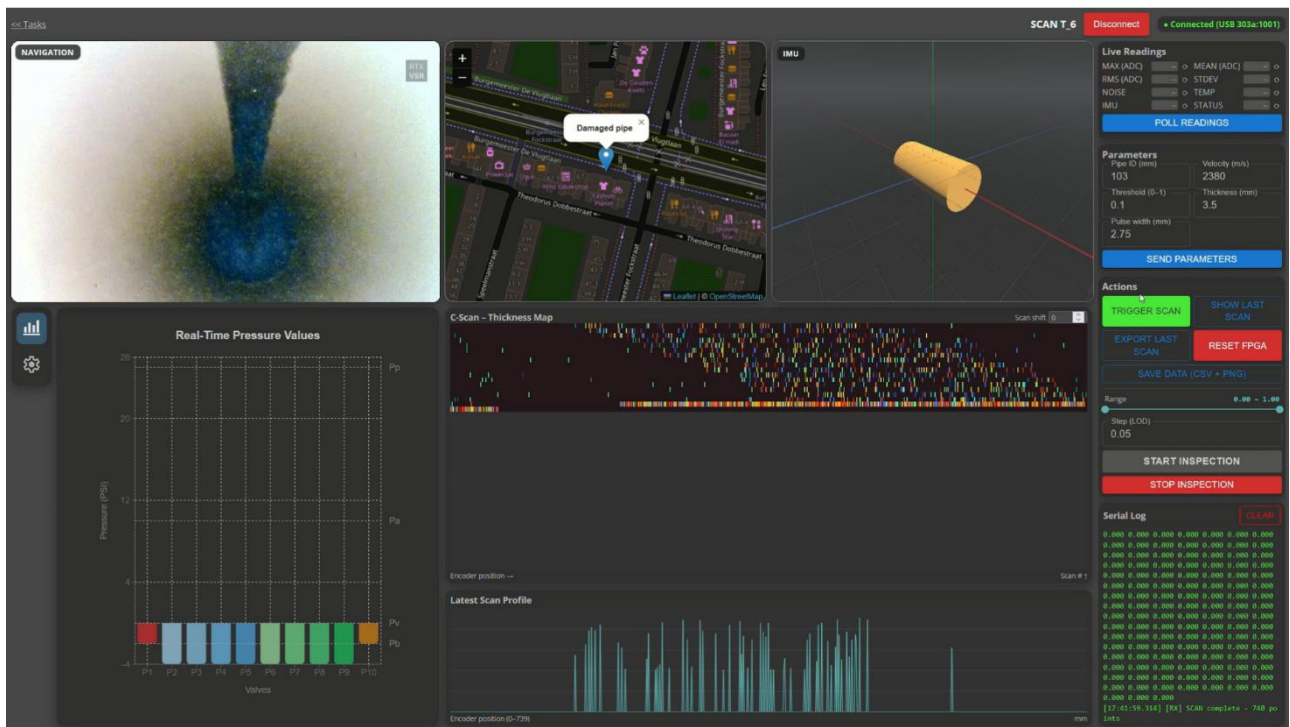
At the leak site the inspection robot anchored with the defect between its distal ends and ran the synchronised ultrasonic sequence from the Inspection GUI (Figure 23). After the operator entered the pipe parameters (internal diameter 103 mm, sound velocity 2380 m/s, nominal wall thickness 3.5 mm, threshold 0.1, pulse width 2.75 mm), each 360° scan was plotted live as a C-scan thickness map and scan profile, next to the navigation camera, the IMU pose, the defect location and the valve pressures. Reliable interpretation of the thickness map depends on the coaxial alignment of the probe (A9), which is the main point to refine for this subsystem.

Figure 23: Integration of the Ultrasonic Module to the Soft Robot and synchronised operation.

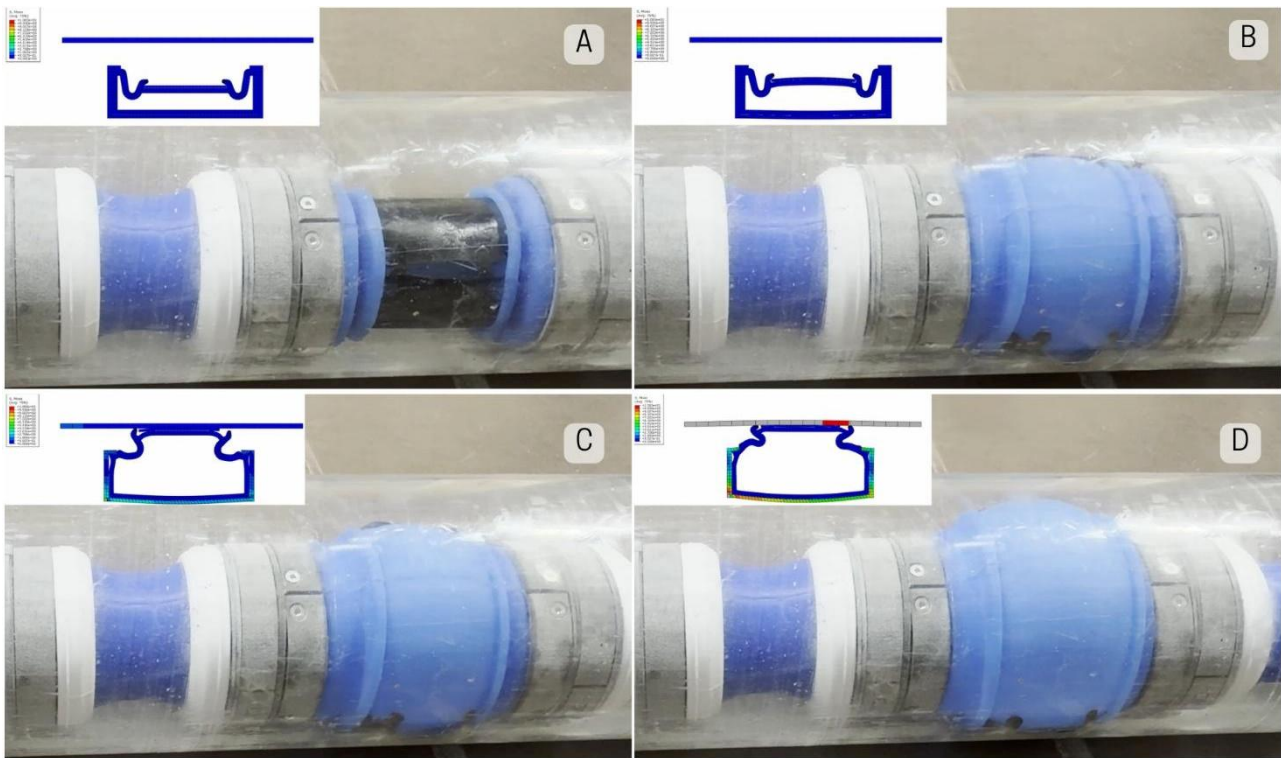
Figure 25: Repair Sequence step-by-step process.

The repair operator selected the task in the Repair GUI and drove the maintenance robot along the same route. Anchoring across the defect isolated a chamber and moved the task to in-progress; the chamber was then dewatered, cleaned and dried, and the tape was deployed (Figure 25). On inflation the slotted actuator unfolds (A–B), the slots reach a critical displacement and tilt outward (C), and the tape is released and pressed onto the pipe wall (D); the insets show the corresponding FEA of the slot mechanism. A final inflation of the front anchor applied homogeneous pressure to secure adhesion. Including these additional inflations, tape deployment took less than 6 minutes on average (M2).

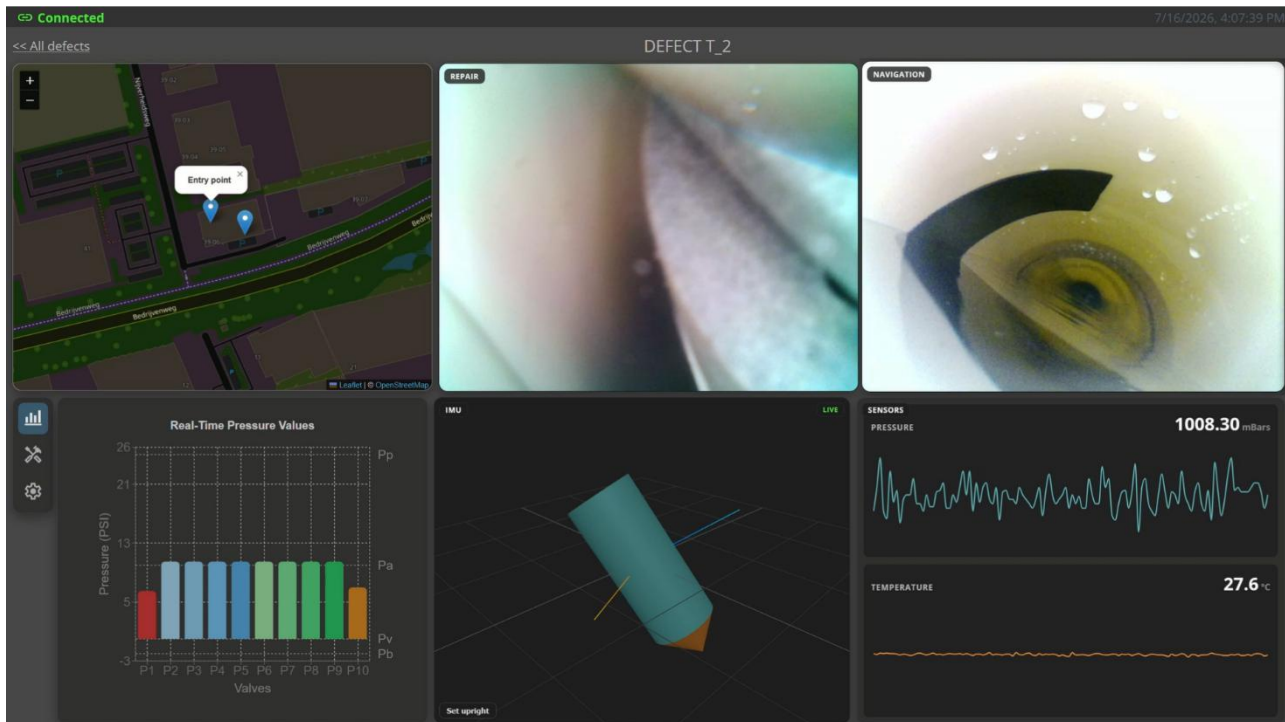
To show underwater adhesion and real-time leak stoppage, water was reintroduced and the isolated chamber was pressurised through the spin-coater nozzle during deployment; the leak stopped as the tape adhered. The chamber was then pressurised again and the repair was inspected from outside with no leakage observed. Throughout the sequence the Repair GUI (Figure 26) gave the operator both camera views, the valve pressures, the IMU pose and the pipe pressure and temperature.

Figure 26: Validation of successful repair operation.

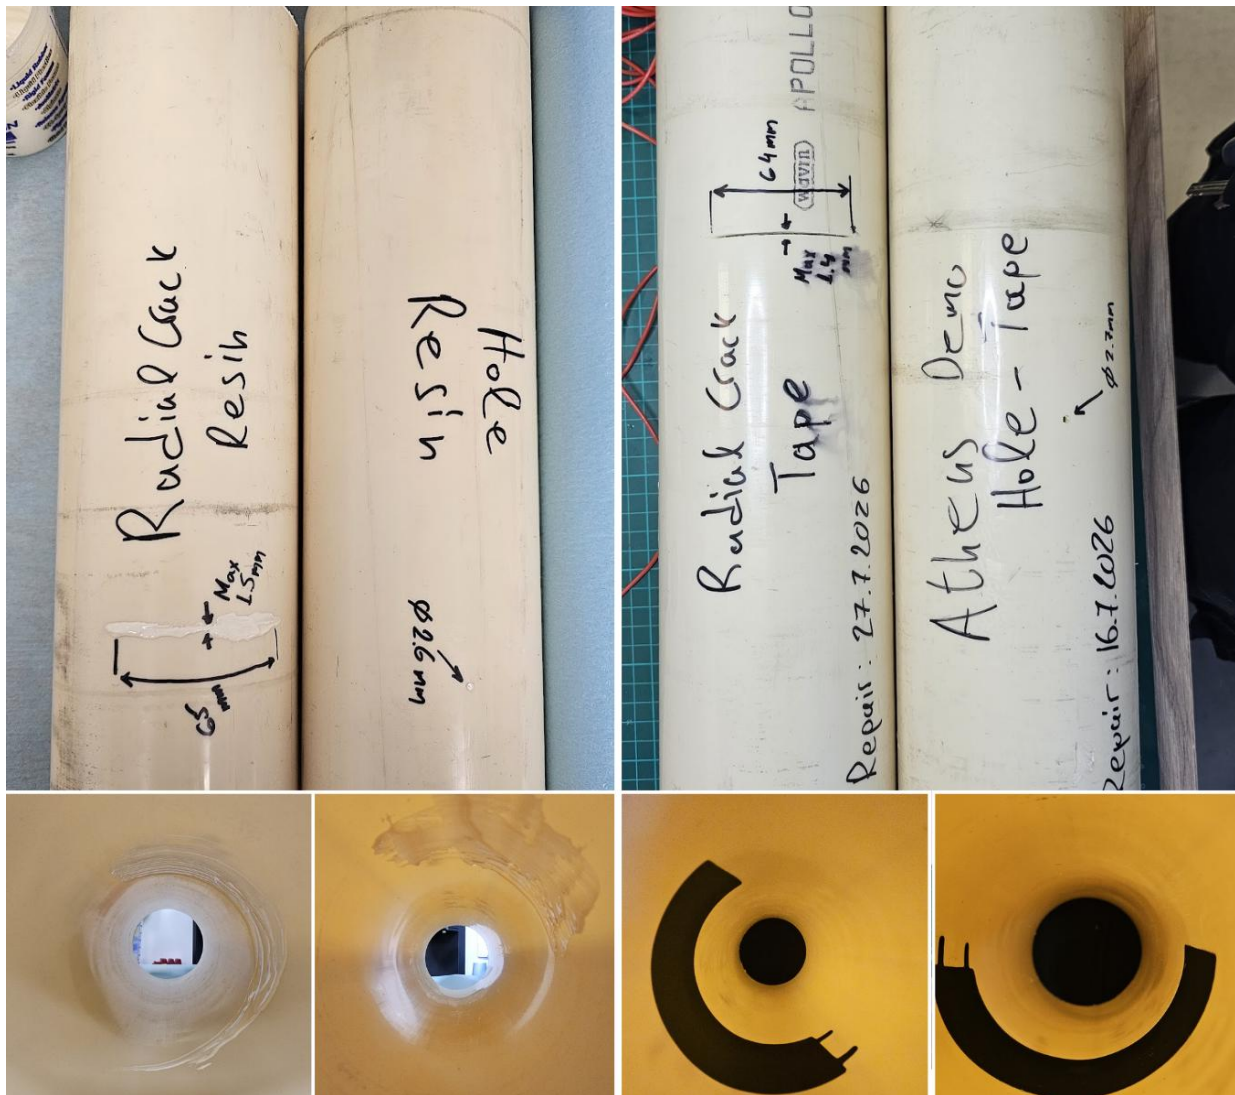
To assess repair quality against industrial practice, four DN110 PE/PVC specimens were repaired with the TUBERS repair tooling and sent to Brabant Water (Figure 29): a  $\approx 2.5$  mm round hole and a radial crack ( $\approx 64$  mm long, up to 1.5 mm wide), each repaired once with the adhesive tape and once with resin spray. The hole–tape specimen is the one repaired during the final demonstration on 16 July 2026.

Figure 29: Repaired pipe specimens sent to Brabant Water for Leakage Testing.

Brabant Water filled each specimen with water and pressurised it from 1 bar up to 10 bar; a repair that reaches 10 bar and holds it for at least 5 minutes is rated successful. **Both tape repairs passed**, holding 10 bar on the hole and on the 64 mm crack. This confirms the underwater tape as the primary repair method and evidences a sealed defect more than three times the 2 cm length targeted in the GA (K2.3). The resin spray repairs started leaking at 5 bar (hole) and 3 bar (crack); improving the material selection process, mixing and in-pipe curing of the resin is retained as a development item for the secondary repair method.
